## Inspection Report

**Property Address:**  
2011 Sample Report  
Newtown NC 88888

2011 Sample Report

**D. P. Edwards & Associates, LLC, Home Inspectors**

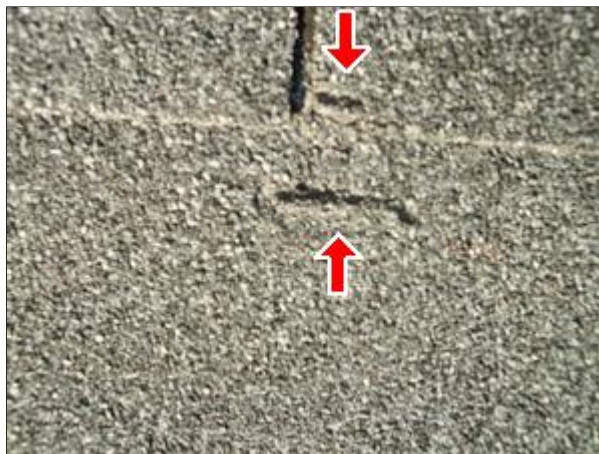
1.0 Picture 1

The Roof shingles are damaged at the covered porch. This damage should be repaired or replaced. A qualified contractor should inspect and repair as needed.

**1.0** The Roof shingles are damaged at the covered porch. This damage should be repaired or replaced. A qualified contractor should inspect and repair as needed.

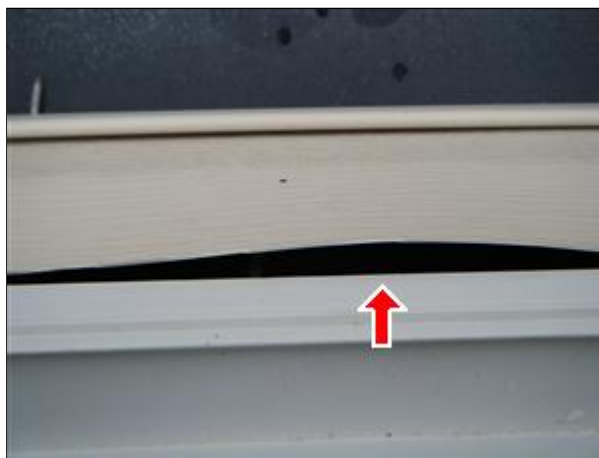
2.0 Picture 1 Looking down from window

(1) The Vinyl siding at the center window above the covered porch is damaged. The siding is gaped open under the window sill. Deterioration can eventually occur if not corrected. A qualified contractor should inspect and repair as needed.

**2.0** (1) The Vinyl siding at the center window above the covered porch is damaged. The siding is gaped open under the window sill. Deterioration can eventually occur if not corrected. A qualified contractor should inspect and repair as needed.

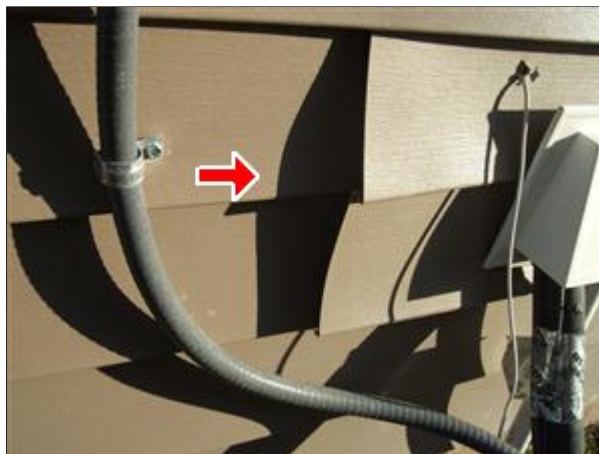
2.0 Picture 2 Loose siding

(2) The Vinyl siding at the rear of home is loose. Picture 1) Deterioration can eventually occur if not corrected. A qualified contractor should inspect and repair as needed.

(2) The Vinyl siding at the rear of home is loose. Picture 1) Deterioration can eventually occur if not corrected. A qualified contractor should inspect and repair as needed.

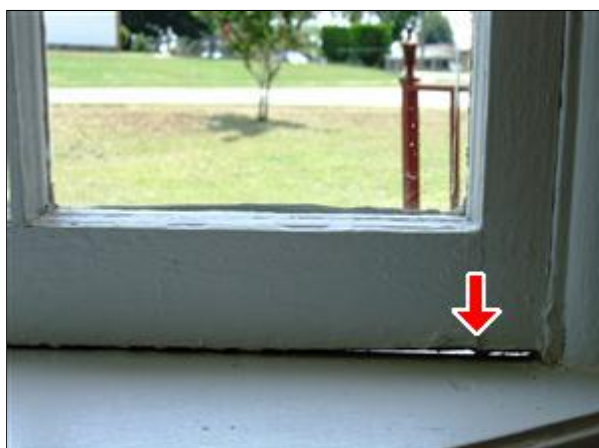
2.2 Picture 1

The bottom sash reveals daylight on the bottom right of the window at front (right of main entry). This can cause some heat loss in winter and loss of cool air in summer if not corrected. A qualified contractor should inspect and repair as needed.

**2.2** The bottom sash reveals daylight on the bottom right of the window at front (right of main entry). This can cause some heat loss in winter and loss of cool air in summer if not corrected. A qualified contractor should inspect and repair as needed.

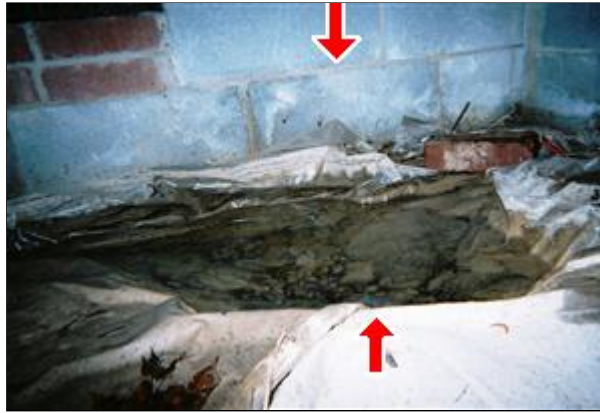
5.0 Picture 1 Up arrow = water down arrow = efflorescence

(1) Visible signs of water intrusion in the crawlspace are present from standing water and efflorescence on foundation wall. Water intrusion can lead to more costly repairs and increase damage if not corrected.. I recommend further investigation or correction by a qualified licensed contractor or water infiltration specialist.

**5.0** (1) Visible signs of water intrusion in the crawlspace are present from standing water and efflorescence on foundation wall. Water intrusion can lead to more costly repairs and increase damage if not corrected.. I recommend further investigation or correction by a qualified licensed contractor or water infiltration specialist.

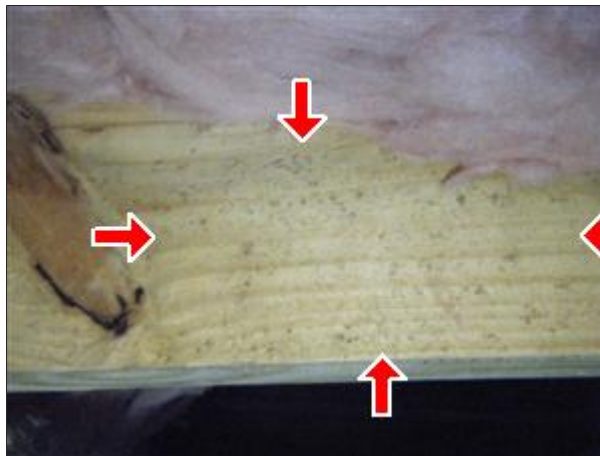
5.0 Picture 2

(2) Signs of fungi growth is present on the floor system in crawlspace in several areas. We did not inspect, test or determine if this growth is or is not a health hazard. The underlying cause is moisture. I recommend you contact a mold inspector or expert for investigation or correction if needed.

(2) Signs of fungi growth is present on the floor system in crawlspace in several areas. We did not inspect, test or determine if this growth is or is not a health hazard. The underlying cause is moisture. I recommend you contact a mold inspector or expert for investigation or correction if needed.

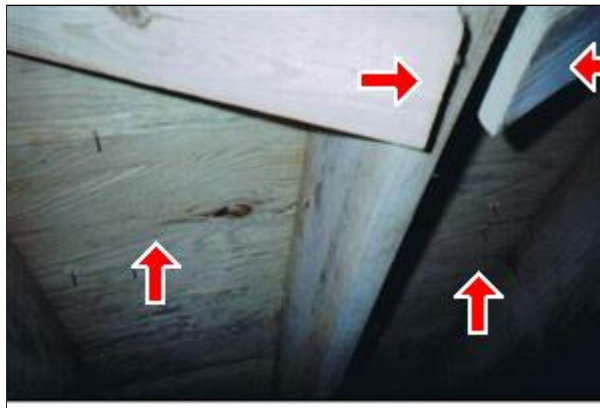
5.3 Picture 1

The lateral bracing of several floor joist(s) were never nailed during construction under the Master Bedroom. Repairs are needed. A qualified licensed general contractor should inspect further and repair as needed.

**5.3** The lateral bracing of several floor joist(s) were never nailed during construction under the Master Bedroom. Repairs are needed. A qualified licensed general contractor should inspect further and repair as needed.

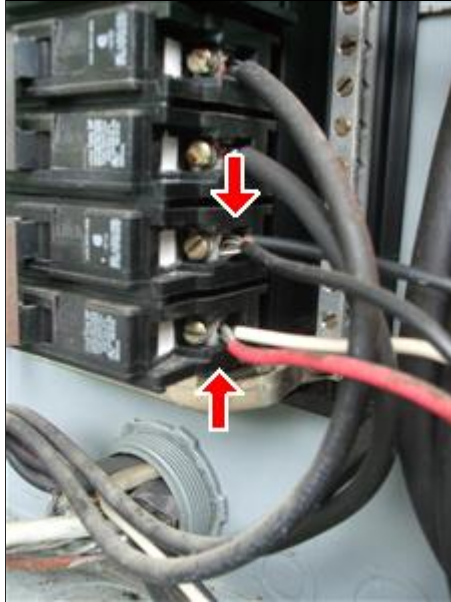
7.1 Picture 1

The problem(s) discovered in the panel such as doubled wiring at circuit(s), and any other problems that an electrical contractor may discover while performing repairs need correcting. I recommend a licensed electrical contractor inspect further and correct as needed.

**7.1** The problem(s) discovered in the panel such as doubled wiring at circuit(s), and any other problems that an electrical contractor may discover while performing repairs need correcting. I recommend a licensed electrical contractor inspect further and correct as needed.

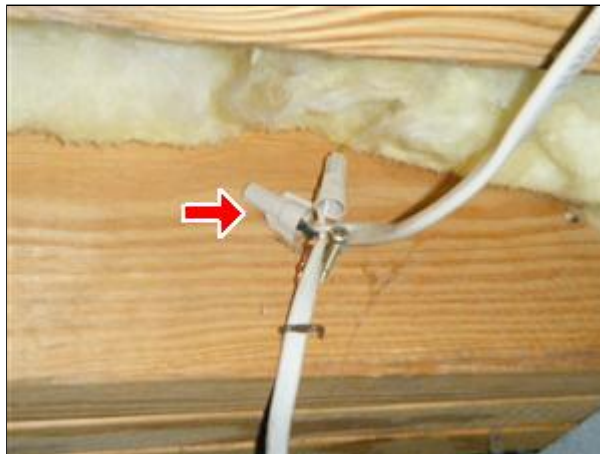
7.2 Picture 1

Problem(s) discovered with Branch Circuits such as wire splices which are not enclosed in covered junction boxes and any other problems that an electrical contractor may discover while performing repairs need correcting. I recommend a licensed electrical contractor inspect further and correct as needed.

**7.2** Problem(s) discovered with Branch Circuits such as wire splices which are not enclosed closed in covered junction boxes and any other problems that an electrical contractor may discover while performing repairs need correcting. I recommend a licensed electrical contractor inspect further and correct as needed.

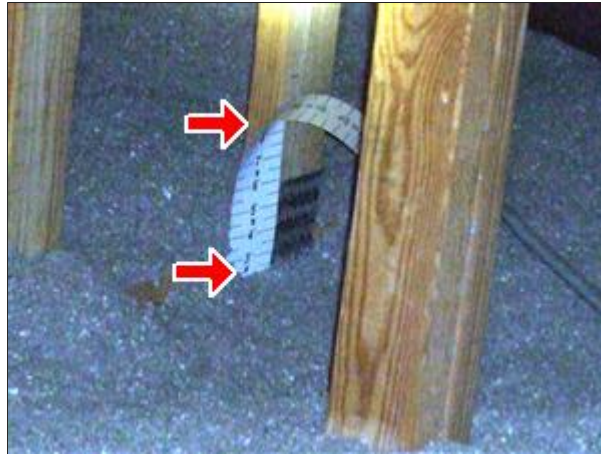
9.0 Picture 1

Cellulose (loose-fill) insulation is unevenly distributed in attic. Heat loss can occur more on this home than one that is properly insulated. A qualified licensed insulation contractor should inspect further and repair as needed.

(Picture 1) The top arrow represents the depth (8.1 ins.) that the data card states is installed. The bottom arrow indicates the actual depth of insulation at that point which is less than 3 ins.

**9.0** Cellulose (loose-fill) insulation is is unevenly distributed in attic. Heat loss can occur more on this home than one that is properly insulated. A qualified licensed insulation contractor should inspect further and repair as needed.

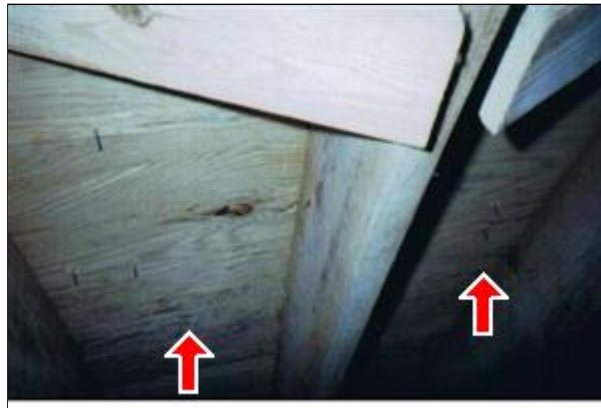
9.1 Picture 1

The insulation is missing under the master bath. Insulation was never installed in this area.. A qualified contractor should inspect and repair as needed.

**9.1** The insulation is missing under the master bath. Insulation was never installed in this area.. A qualified contractor should inspect and repair as needed.

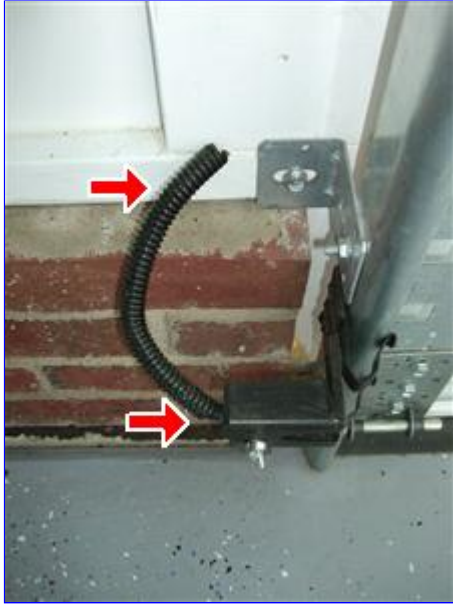
[An example of a really clean control wiring for automatic garage installation.](#)

3.3 Picture 1 Control wires in conduit

**3.3** An example of a really clean control wiring for automatic garage installation.

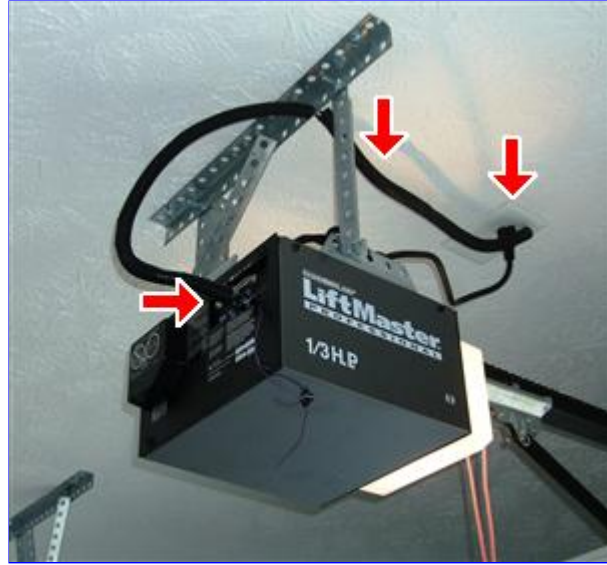
3.3 Picture 2 Wiring to operator

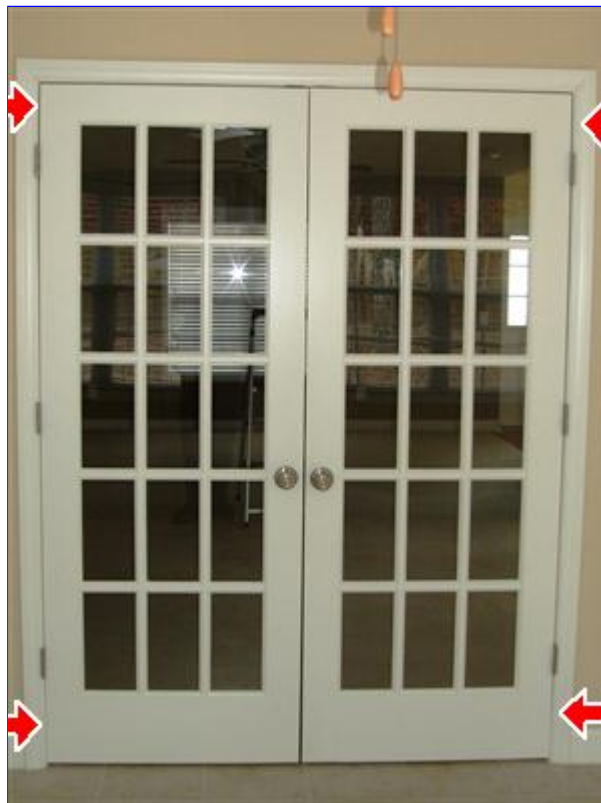
4.5 Picture 1

The French doors do not fit opening properly (out of square) at the Living Room. Since the doors open and close properly this is cosmetic and for your information. A qualified person could estimate the cost of repair to help you determine whether to correct the situation.

**4.5** The French doors do not fit opening properly (out of square) at the Living Room. Since the doors open and close properly this is cosmetic and for your information. A qualified person could estimate the cost of repair to help you determine whether to correct the situation.
